SEISMIC TEST

ELECTRICAL PANEL-PANOSIS OTOMASYON-PSS-4000 A, FORM 4B

TEST REPORT

RAT-MTL-ELE25-054-R00

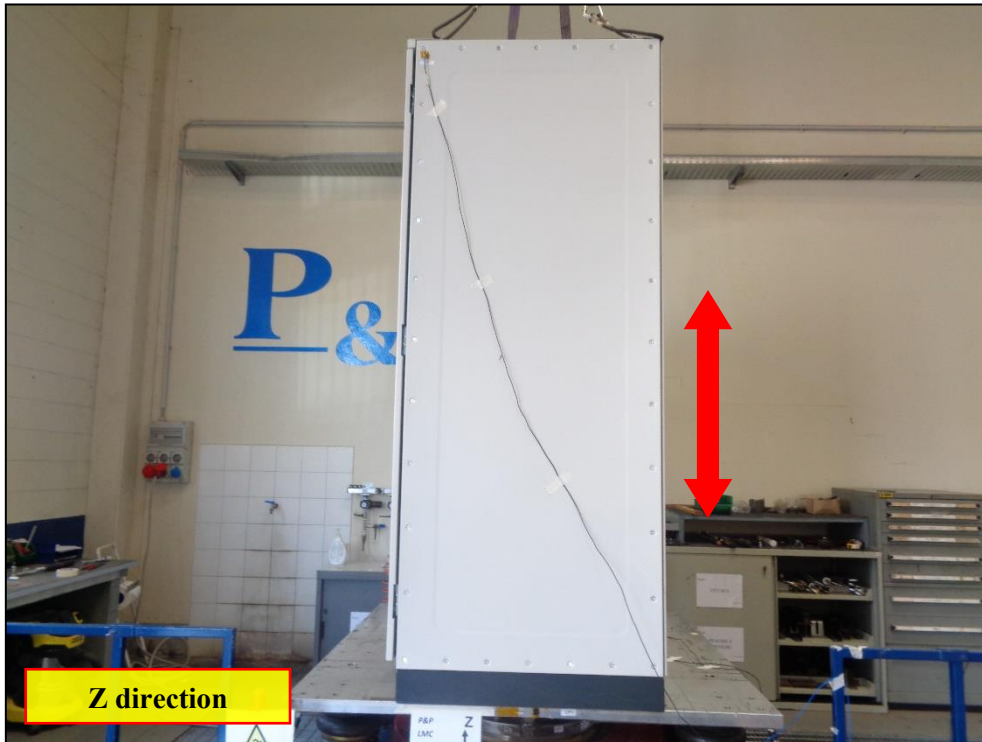
Photo 1 – Test configuration in Z direction

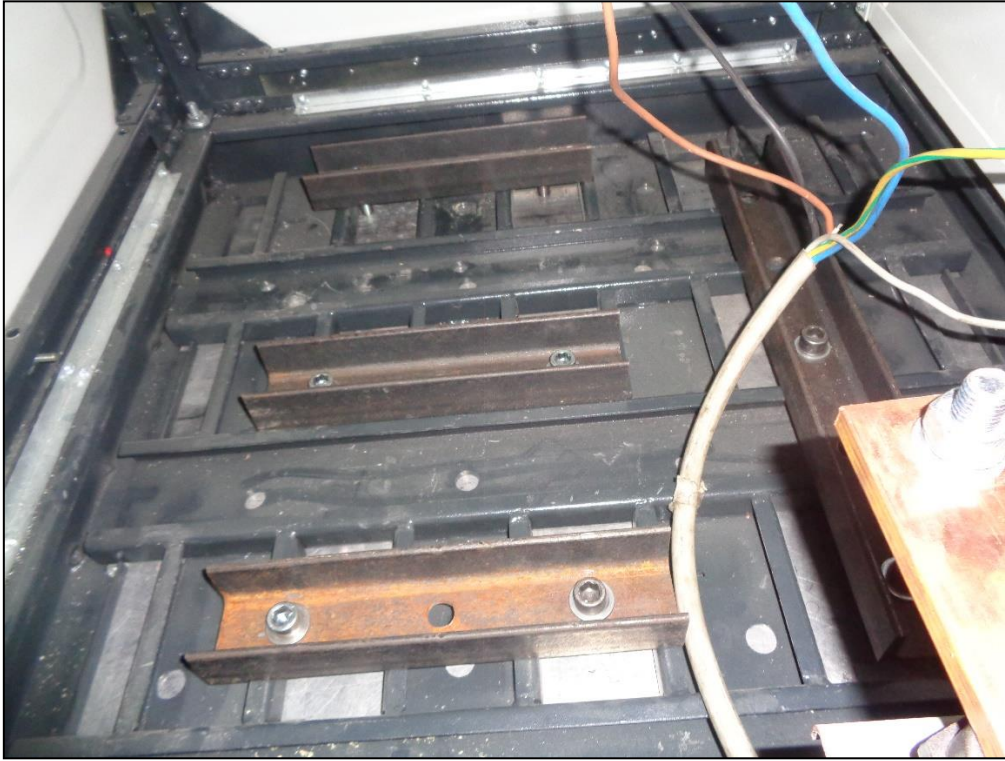
Photo 5 – Mounting technique – fixing points

For the seismic test, the base of the unit was fixed onto the expander 1500x1500 mm of the vibration shaker by means of steel stirrups and n. 17 M14 bolts, with tightening at a torque of 80 Nm (ref. Photo 5), to reproduce the assembly operating conditions established by the Customer.

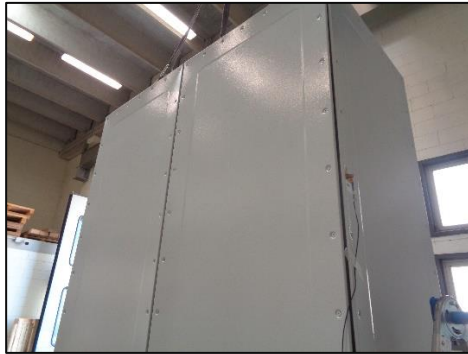
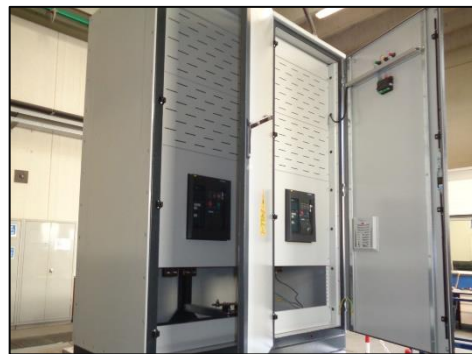
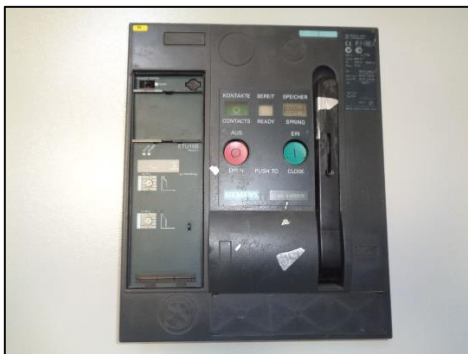
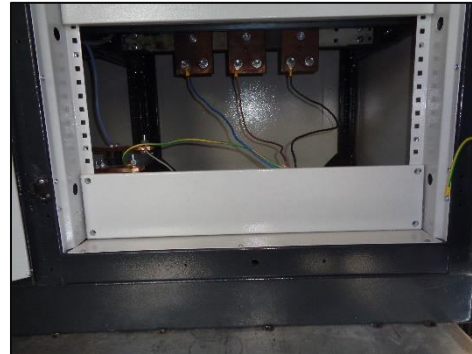
Photo 10 – Final visual inspection after all direction tests

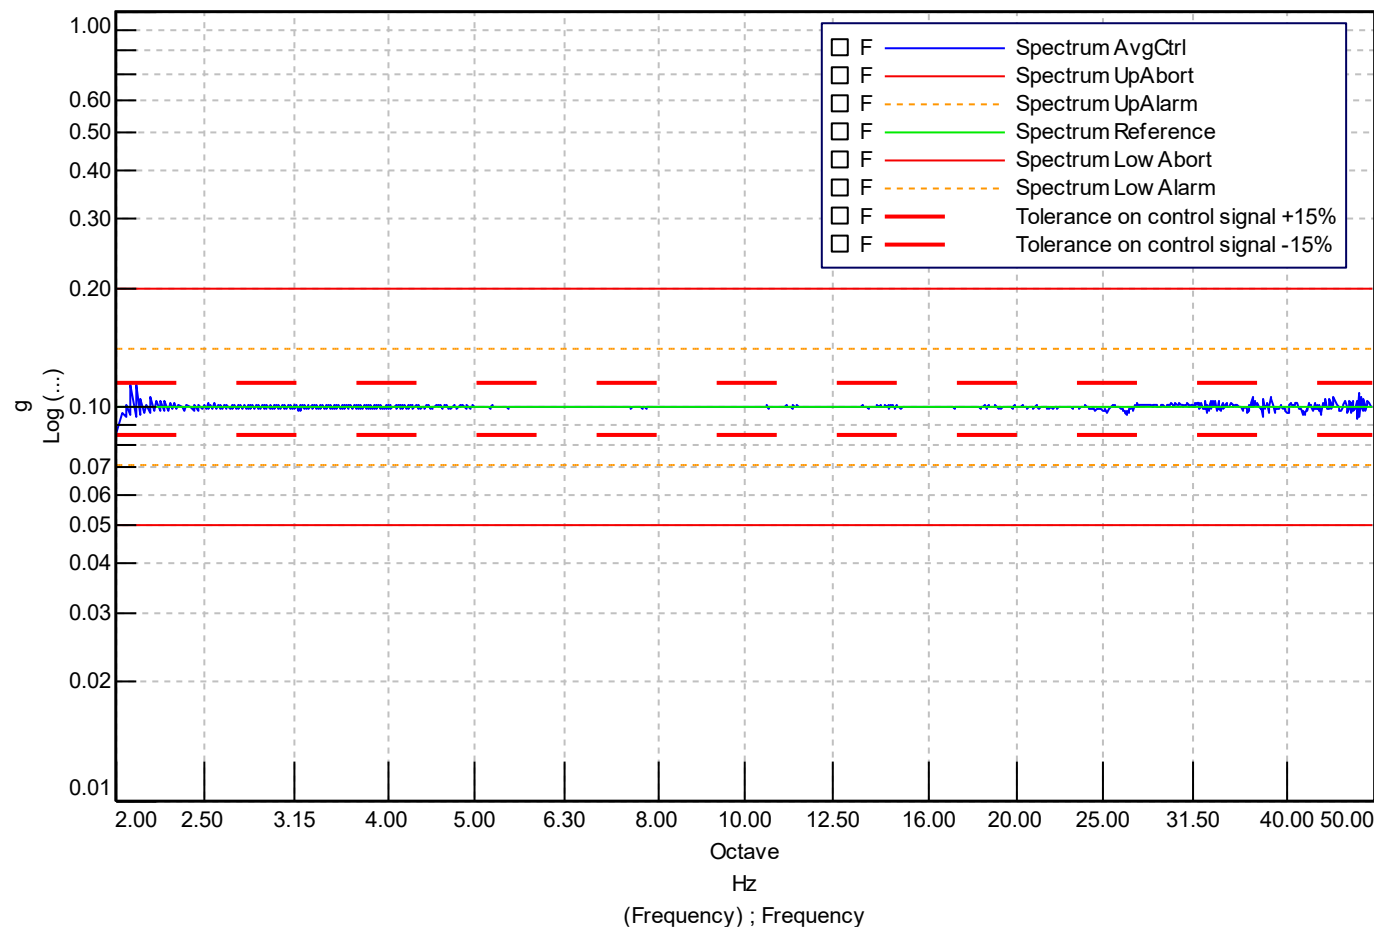
Project: PRO-MTL-ELE25-032
Section: Z_AXIS
Run: RUN01_Sine_1
Date: Tue Sep 16 2025 12:39:04
Sweep direction: Up
Sweep rate: 1 Oct/min
Sweep done: 2
Number of control channels: 1
Point id: AvgCtrl
Control strategy: Average

Figure 3 – Z Axis – AvgCtrl: Diagram of initial vibration response investigation test – Sweep Up

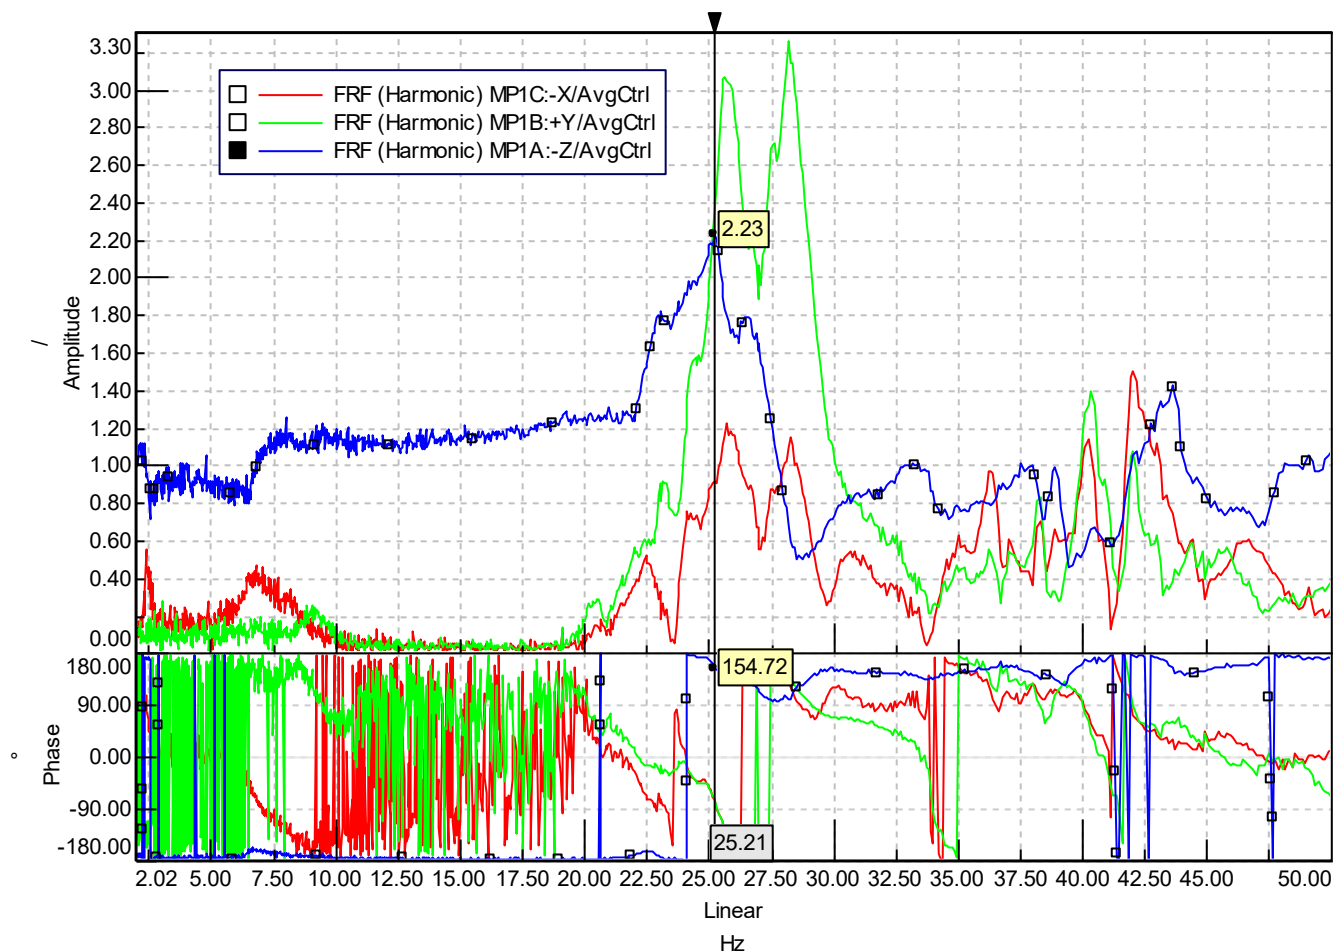
Figure 4 – Z Axis – MP1: Diagram of initial vibration response investigation test – Sweep Up

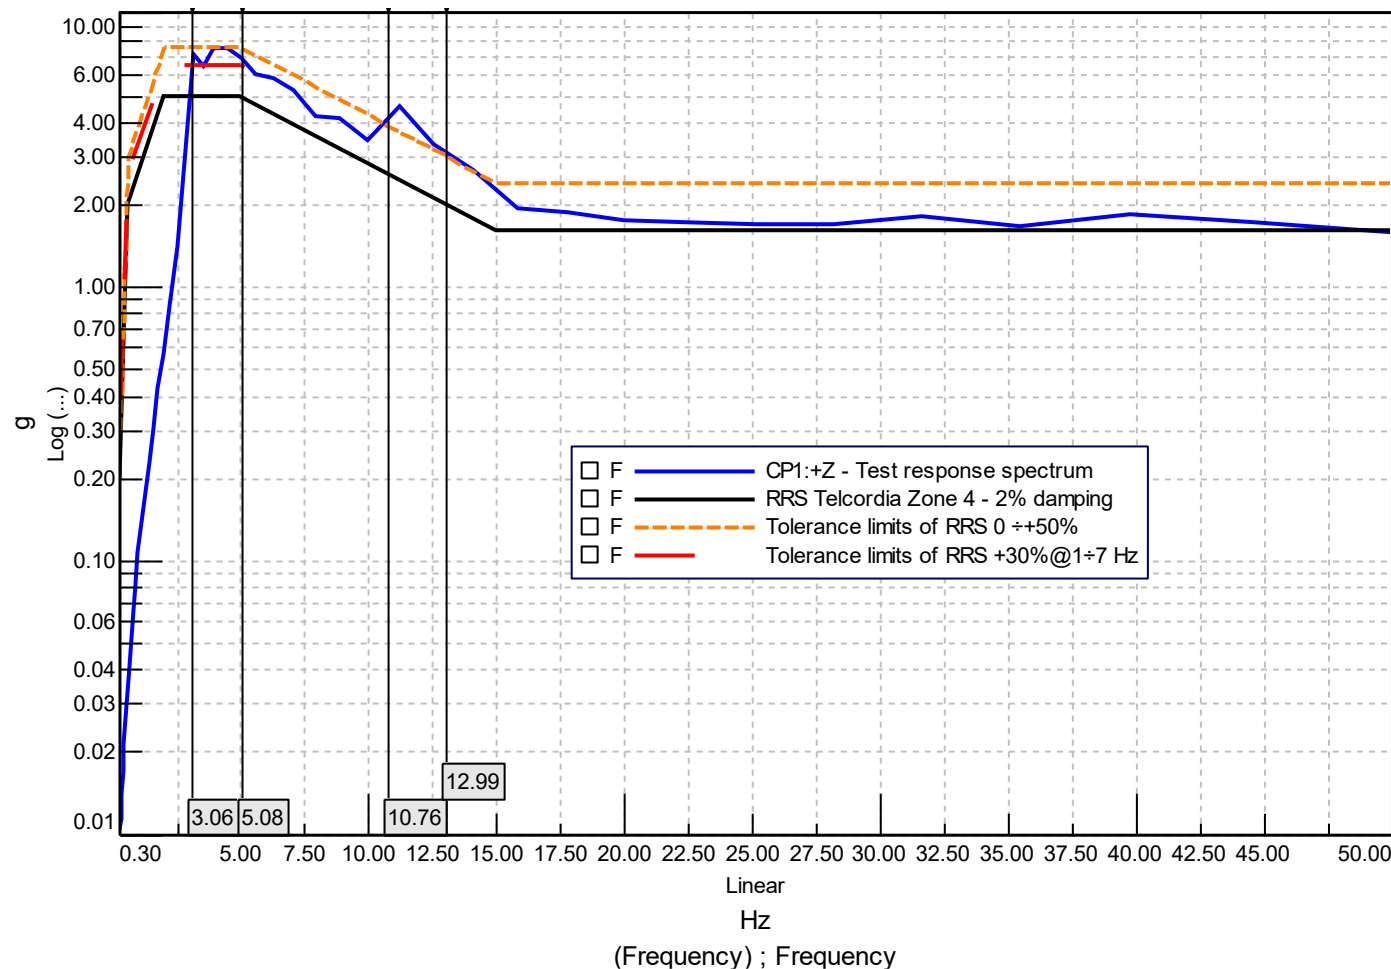
Figure 11 – Z Axis – AvgCtrl: Diagram of Test Response Spectrum

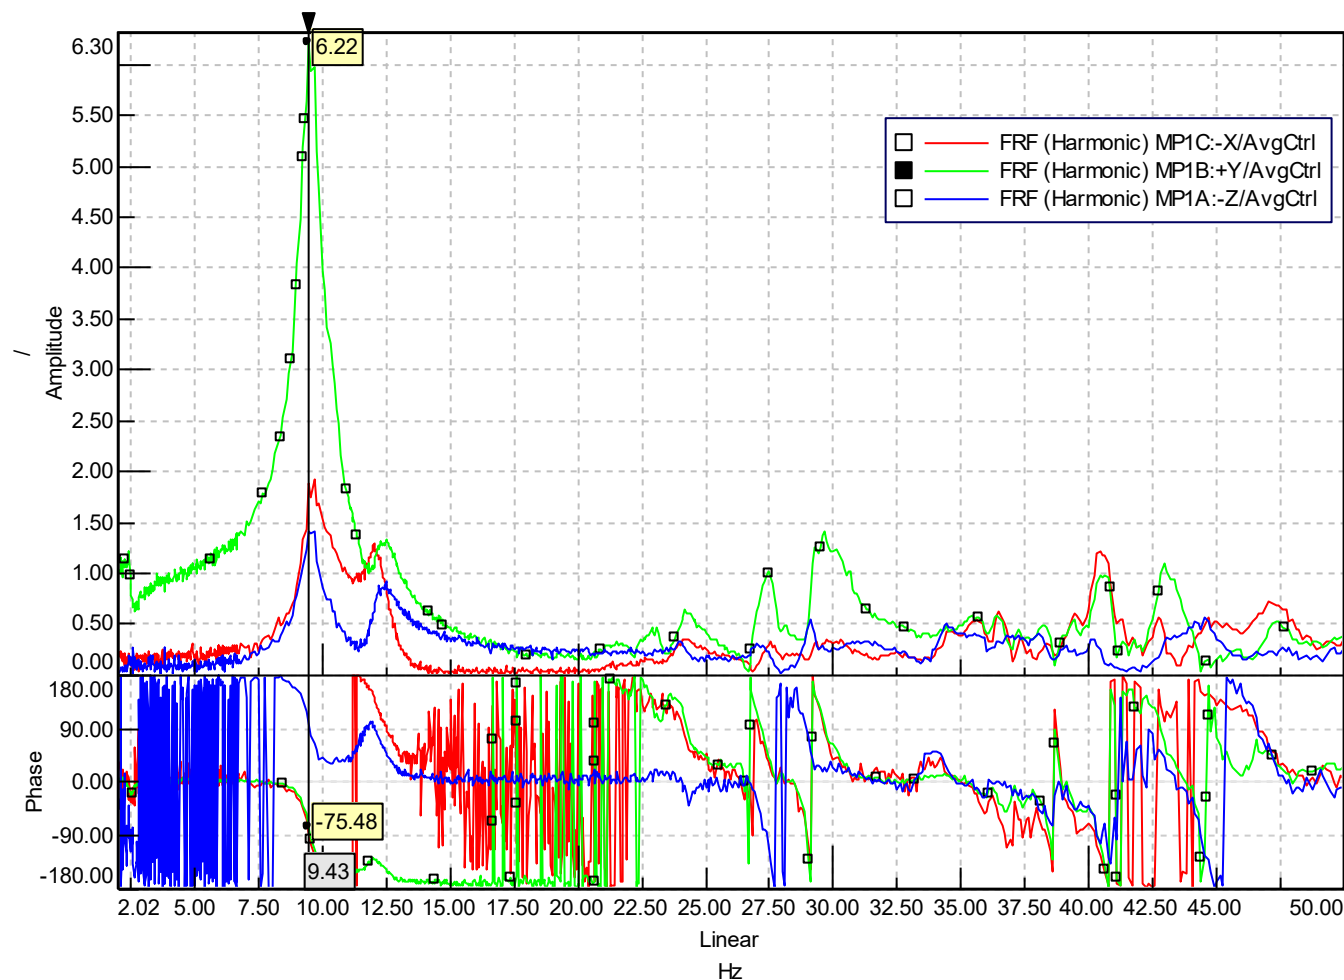
Figure 18 – Y Axis – MP1: Diagram of initial vibration response investigation test – Sweep Up

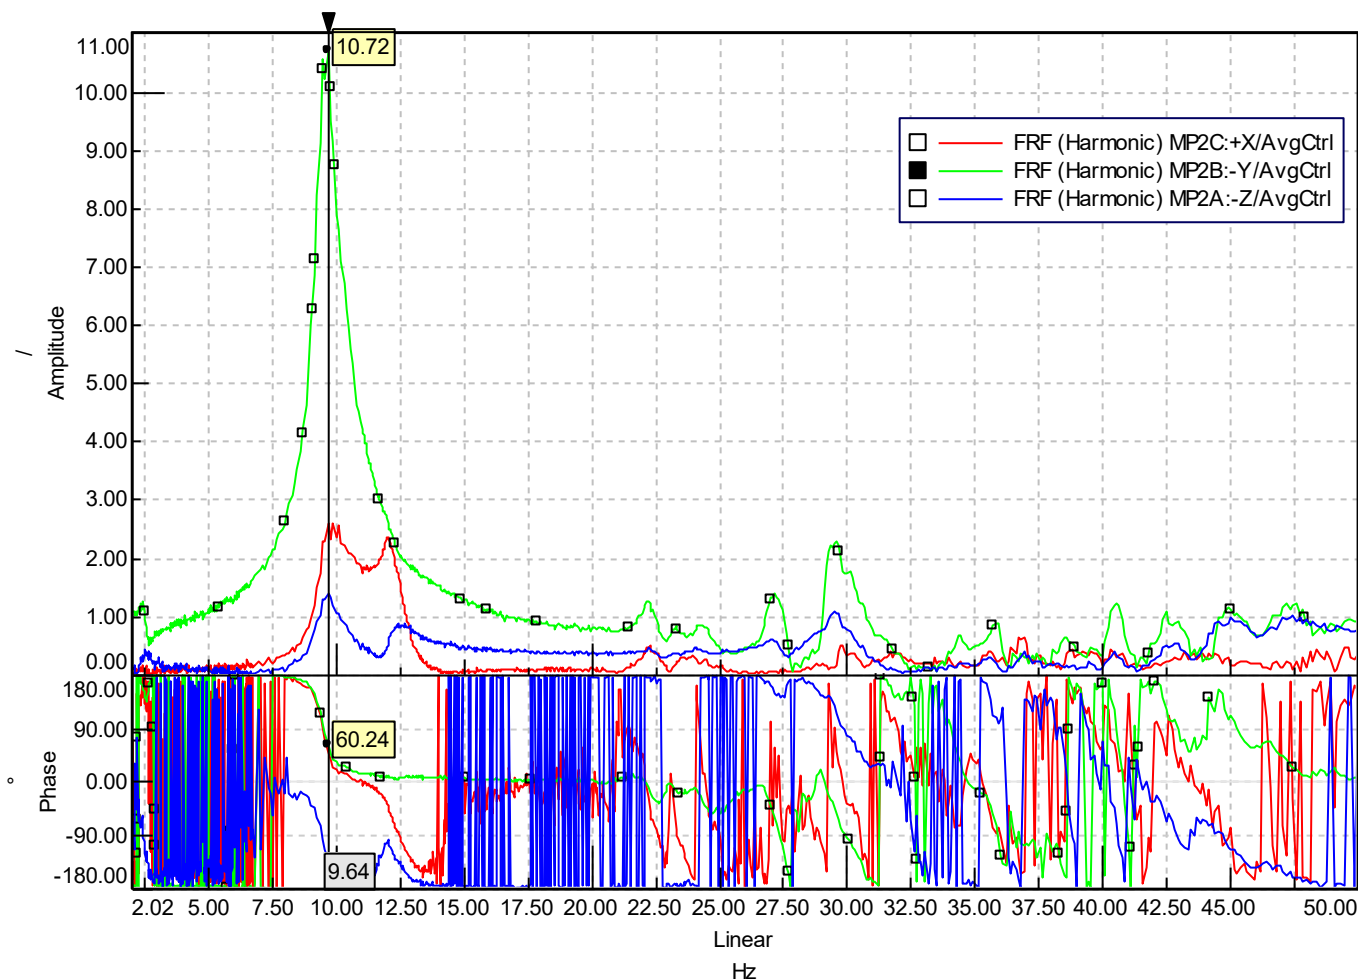
Figure 19 – Y Axis – MP2: Diagram of initial vibration response investigation test – Sweep Up

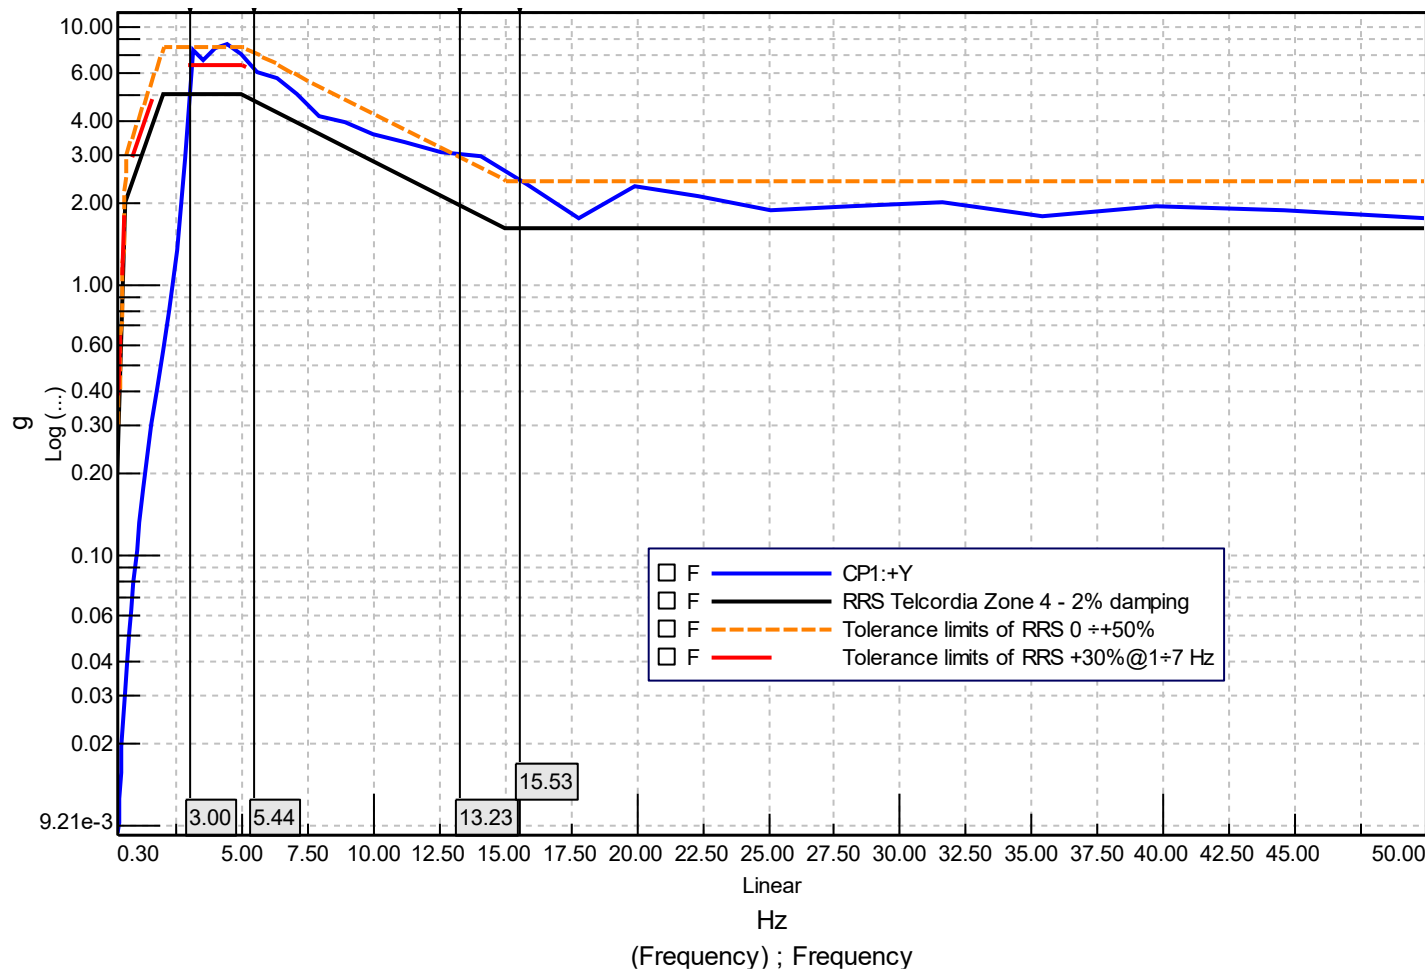
Figure 25 – Y Axis – AvgCtrl: Diagram of Test Response Spectrum

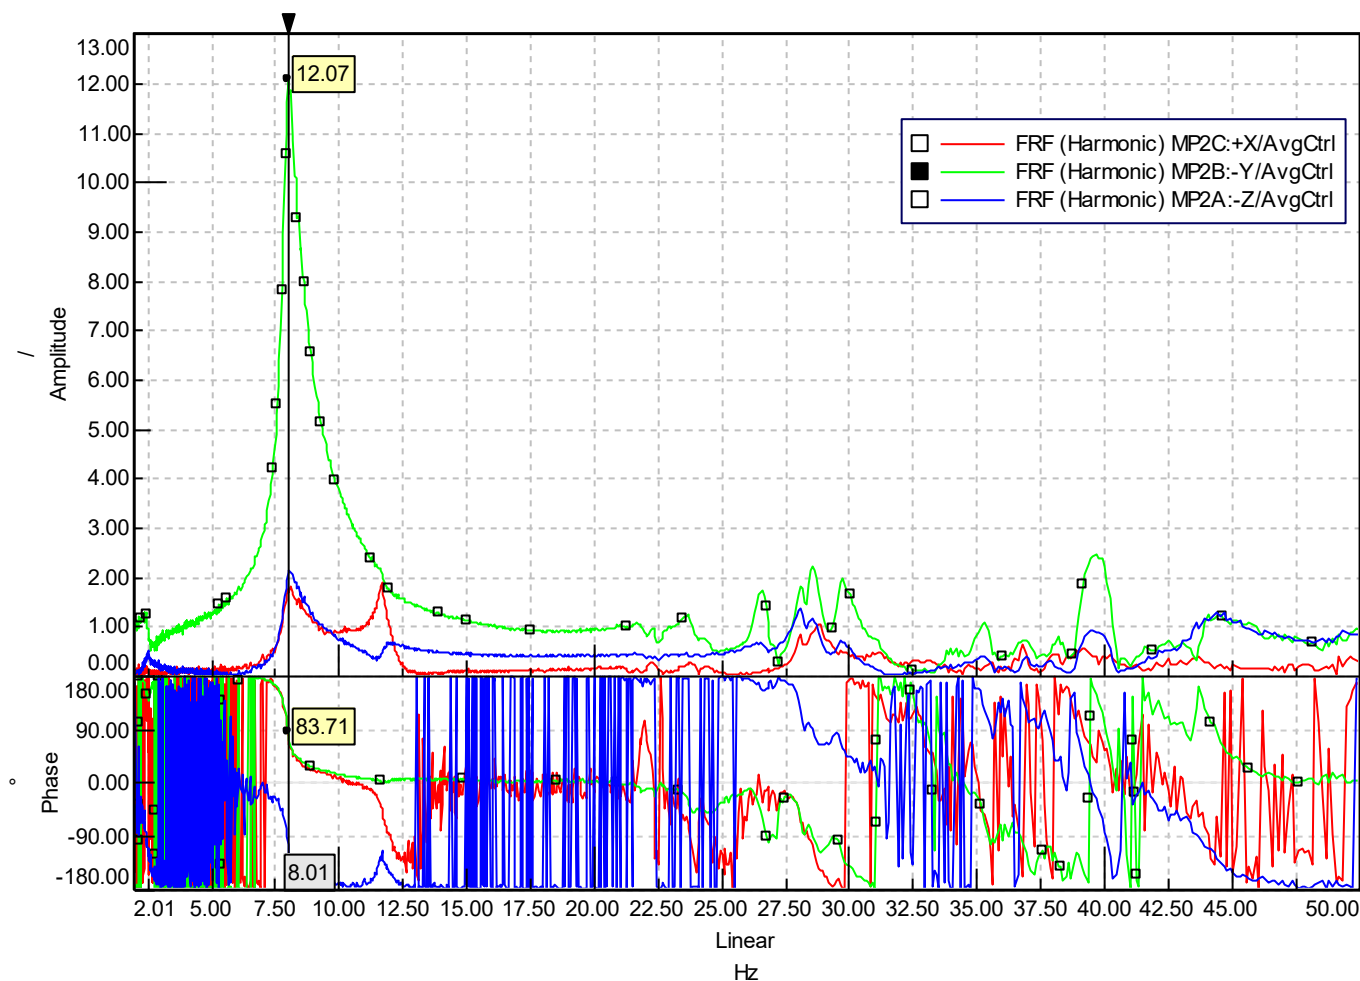
Figure 29 – Y Axis – MP2: Diagram of final vibration response investigation test – Sweep Up
